Report on the
24th Season of the Joint Swiss-Egyptian Mission
in Syene / Old Aswan (2024)

1. Introduction: The current status of site management

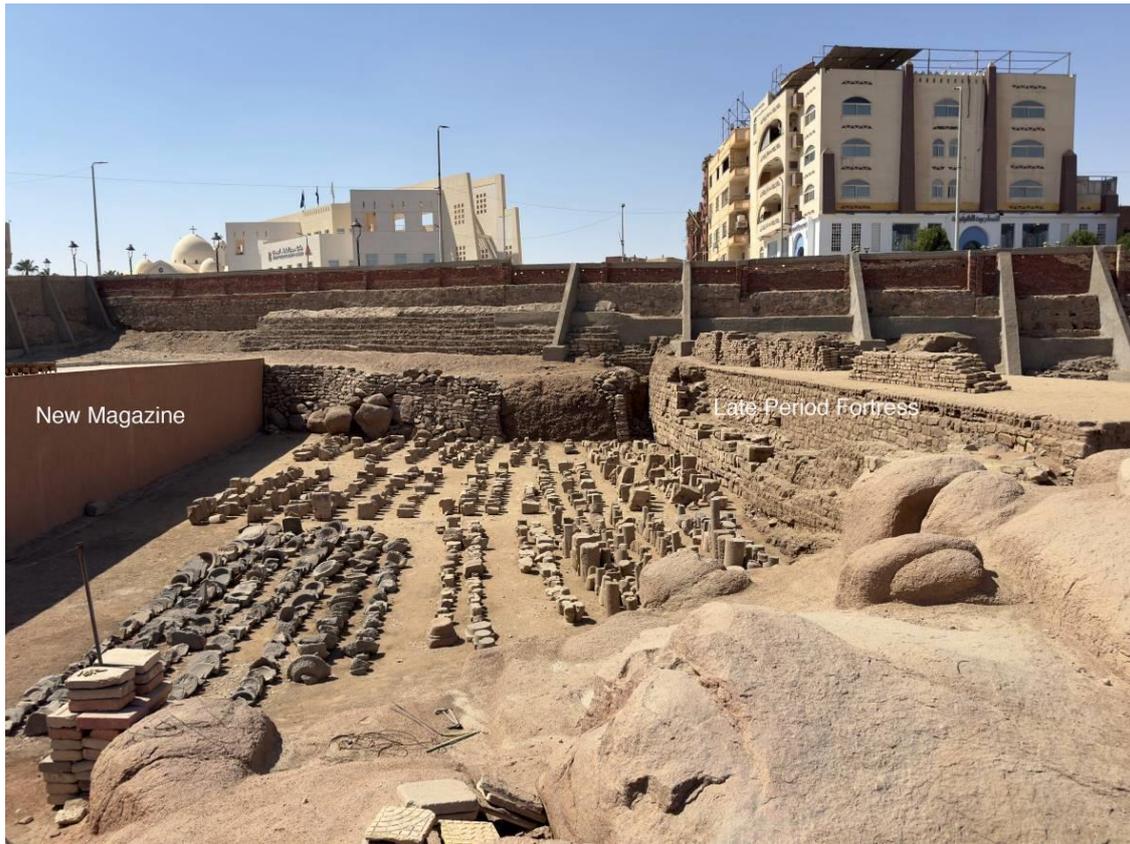
Fig. 1: Overview of the southern part of Area 2 with magazine (left), town wall/Late Period fortress (right), and storage area with spoliae and stone artifacts in the centre.

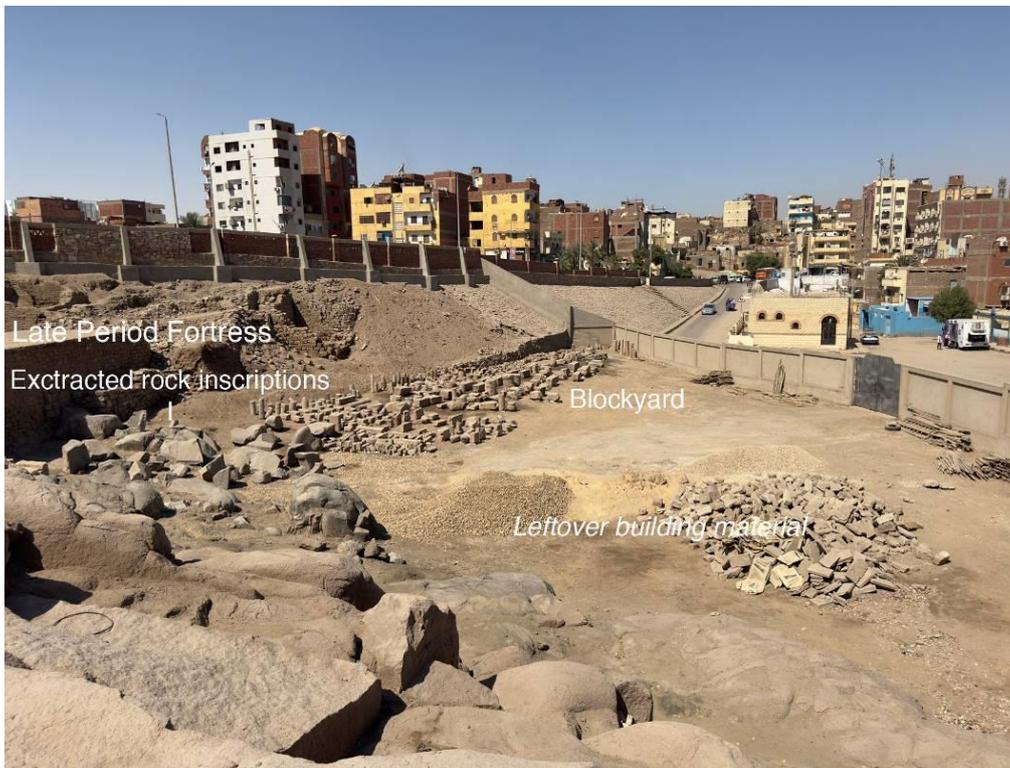
Fig. 2: Overview of northern part of Area 2 with the block yard of the Joint Swiss-Egyptian Mission at Old Aswan.

The decision to build a storehouse with study rooms in Area 2 was closely linked to the concept of using the remaining open spaces in this area to assemble all the architectural elements and larger stone artefacts that have been found in the city of Aswan in recent decades. Several hundred artefacts have already been moved there from the nearby Isis Temple area and from the storage area in Talaina near the reservoir in recent campaigns. Smaller decorated temple blocks and stone artefacts such as oil mills, grinding stones and unfinished stone bowls in various states already occupy the narrow strip directly in front of the magazine, where they are arranged according to object groups ready for further study (Fig. 1). A large number of rock inscriptions extracted in the urban area during rescue excavations and large architectural elements such as columns, capitals, column bases and other large stone blocks were gathered in the northern half of the area, outside the ancient fortress wall (Fig. 2). A large number of other

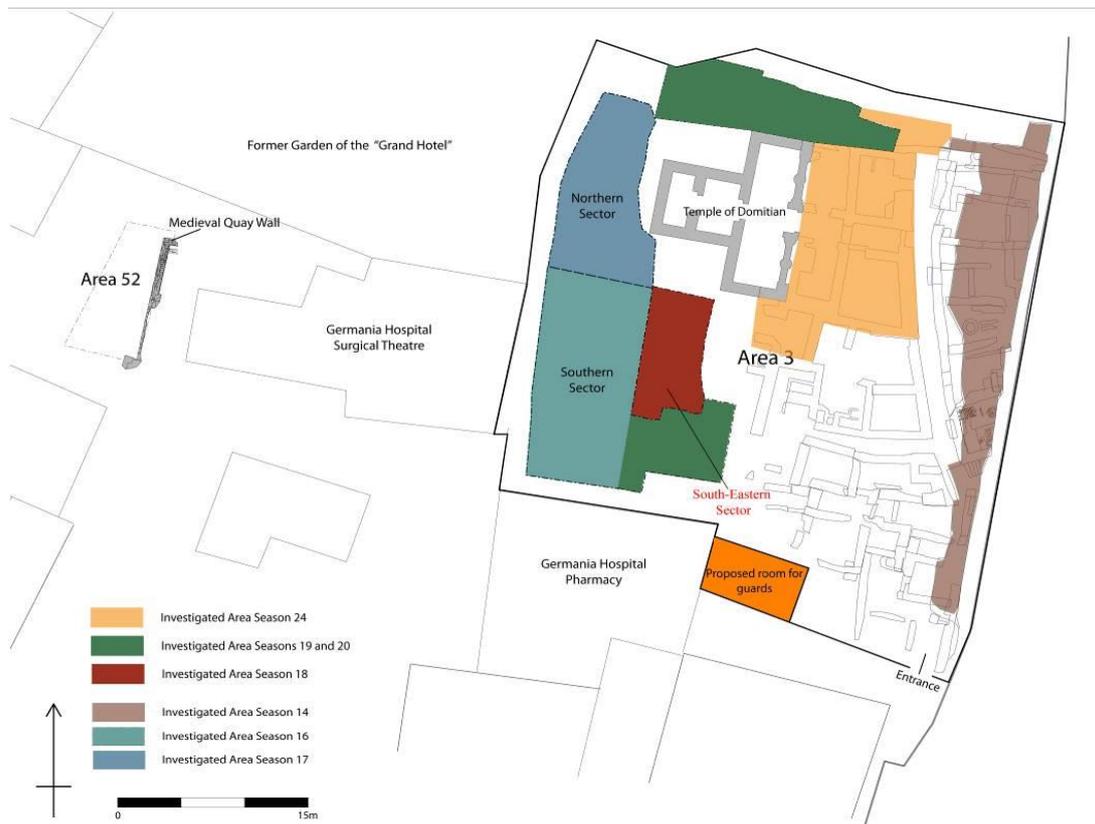
Fig. 3: Area 3: excavated areas and proposed location of the guardhouse.

Subsequent excavations in Seasons 16-19 (Fig. 3) were mostly focussed on the westernmost part of the area, at the bottom of a steep slope.¹⁹ Here later layers had been removed in the late 19th and early 20th century, most probably due to the construction of the German Hospital and the former Grand Hotel, both situated just to the west of Area 3. Here, stone-chips, tools and fragments of such items, and evidence of quarrying, loading and transport of granite, were found on top of the bedrock. Pottery associated with these earliest traces of human activity dated from the Old to the New Kingdom. The most important discovery was a town quarter dating to the Late Period, erected on top of the quarry debris.

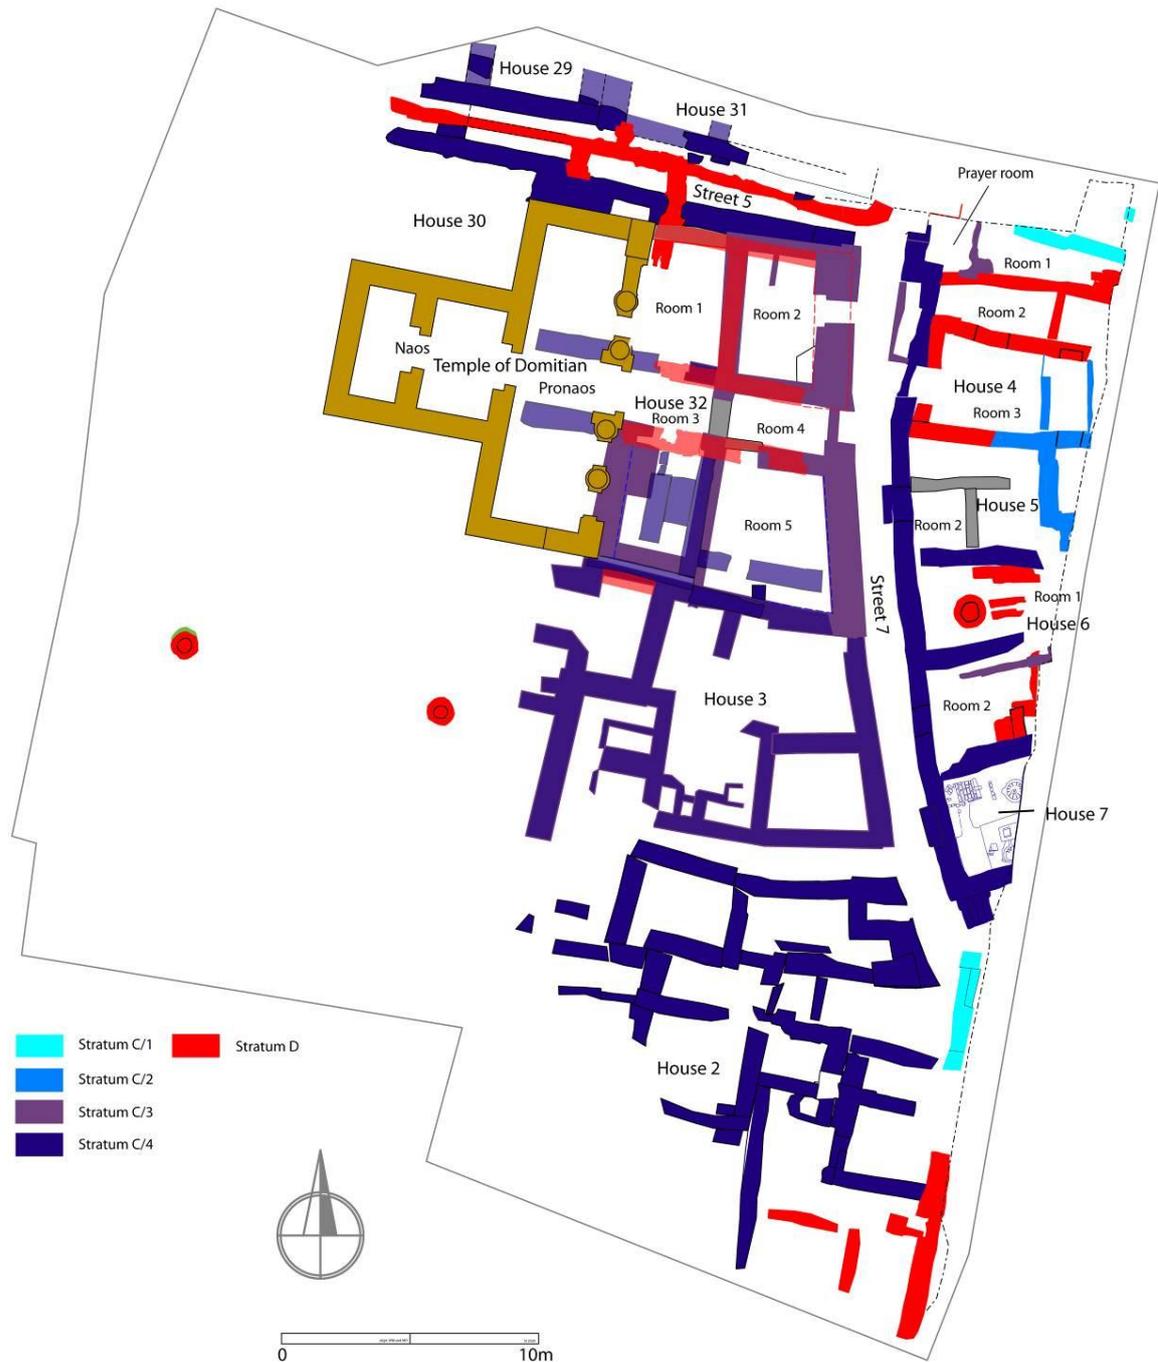
Fig. 6: Map of Area 3 in the medieval period.

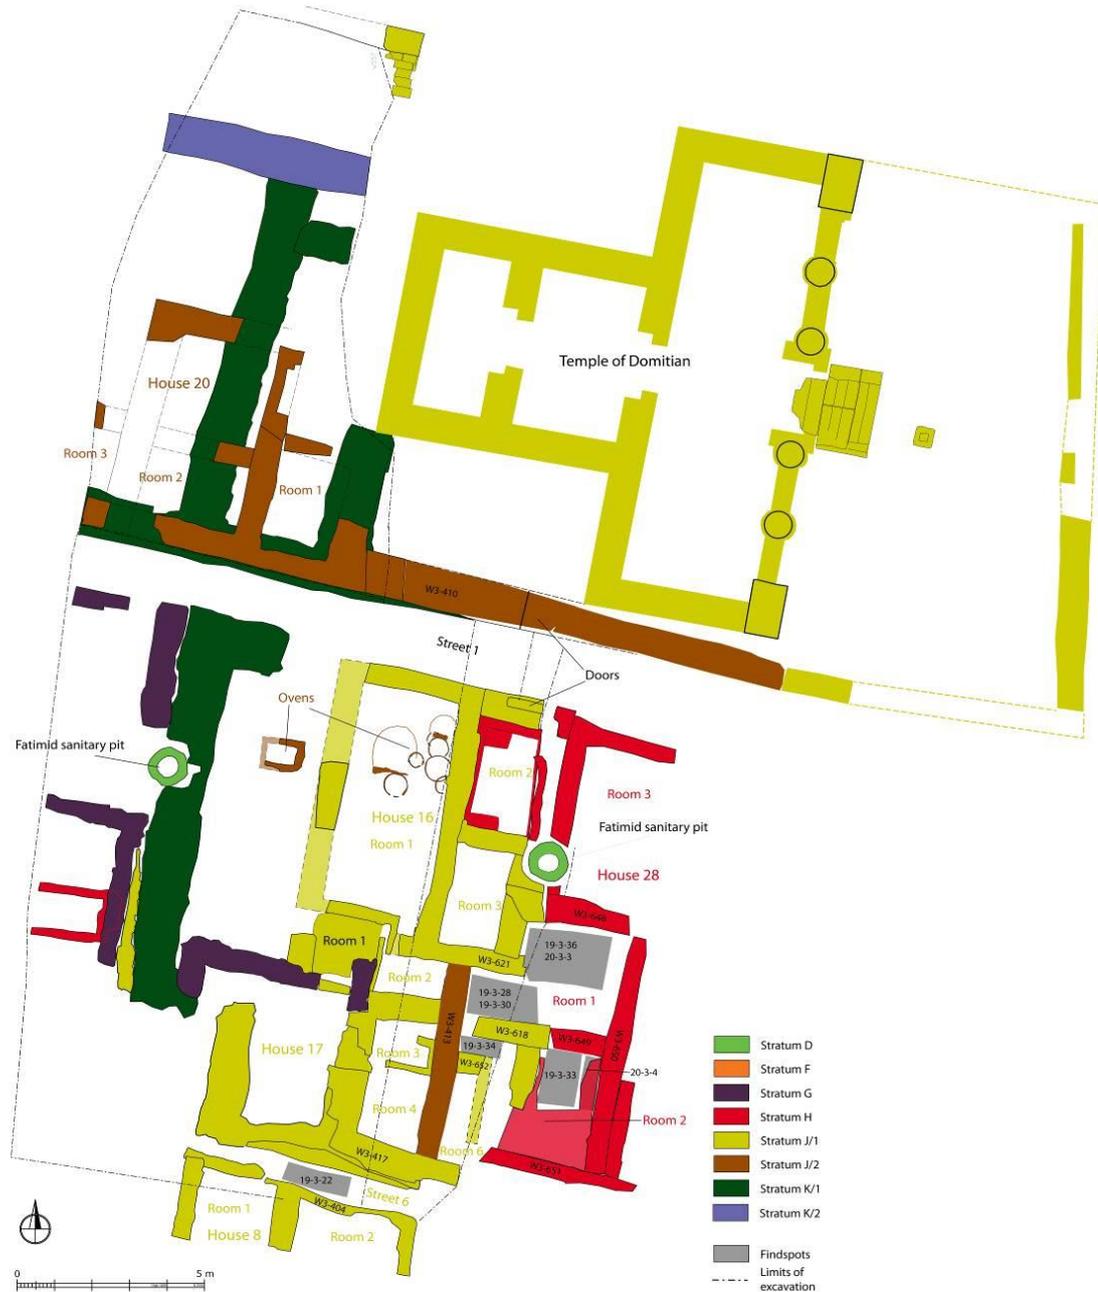
Fig. 7: Map of Area 3 in the Ptolemaic and Roman Imperial periods.

The latest structures encountered there were dated to the Ptolemaic period (Stratum J). In this context, House 20 was the most important (Figs. 7 and 31). It was constructed in the 2nd century BC and inhabited well into the Roman Imperial Period. While in the excavated area to the west of the site only few courses of mud bricks and scarce remains of floors were found, the house was preserved to a height of more than 2m under the Temple of Domitian further to the east.²⁰

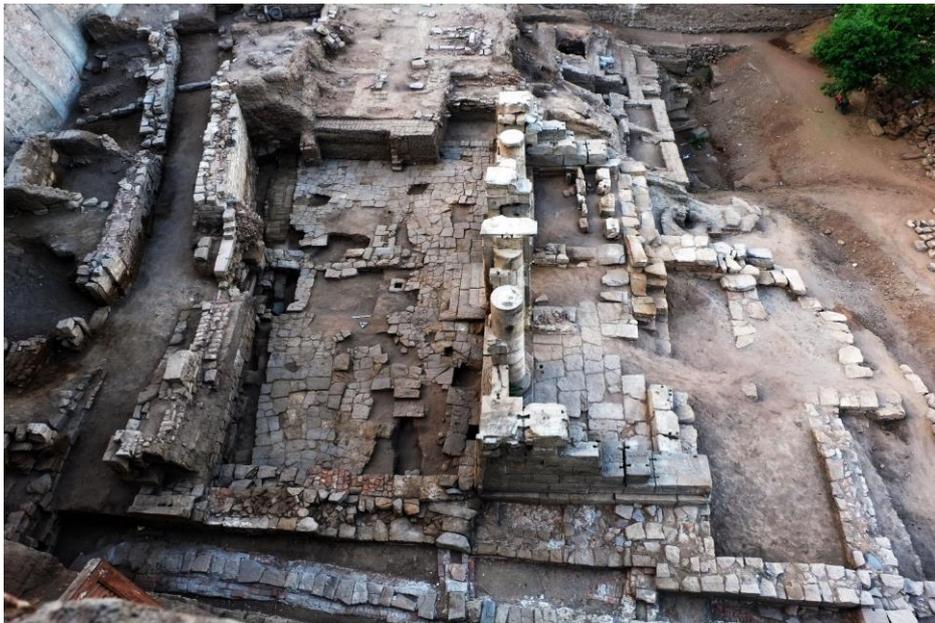
Fig. 8: Overview of the Temple of Domitian from the north.

Today, only parts of the Pronaos are preserved. Of the inner parts of the temple proper, only the foundations still exist (Figs. 8 and 31). Most of the eastern façade of the Pronaos is still standing nearly to its original height. In three places, the intercolumnar walls were broken through. The single breach in the northern part of the façade might have served as a door during the medieval reuse of the temple. The same might be true of the southern more regular breach in the southern part of the façade. In the case of the southernmost breach, the destruction might simply be due to stone robbery.

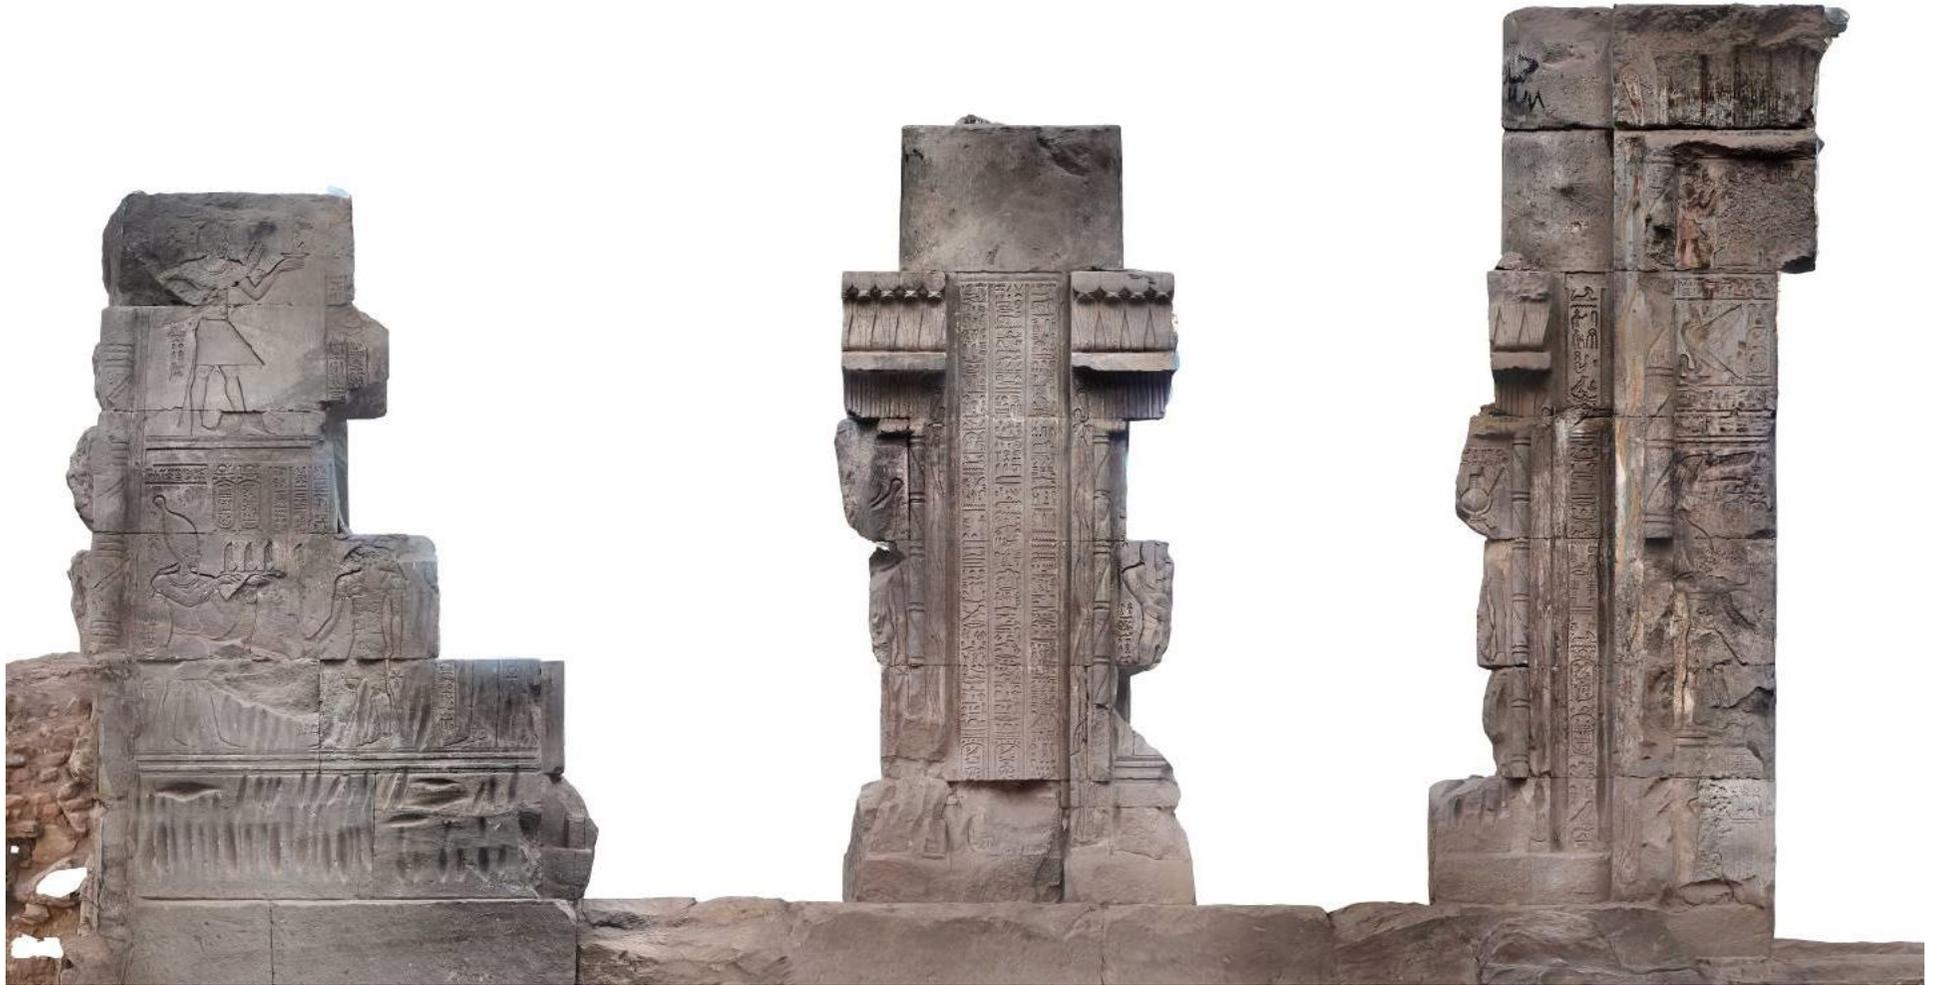
Fig.12: Orthomosaic from a 3D SfM model by Carmen Rac.

At the southern end of the façade, two registers of sunk reliefs are preserved (Figs. 12 and 13). In the top register, the emperor stands on a *pt* sign and looks towards the north. He wears an *Atef*-crown and presents a small bowl with a miniature Maat-figure in it. The god who is addressed is lost. In the lower, better preserved, register, the standing emperor looks towards the north and wears the White Upper Egyptian crown. He presents what looks like the hieroglyph for *sm* (land)⁴⁵ to the god Khnum. The god stands in front of the other gods of the triad of Elephantine, Satet and Anuket. Of these goddesses, only the legs of the first goddess are preserved. The figures stand on a tripartite baseline. The lower second register and the undecorated soubassement are covered with gouges.⁴⁶

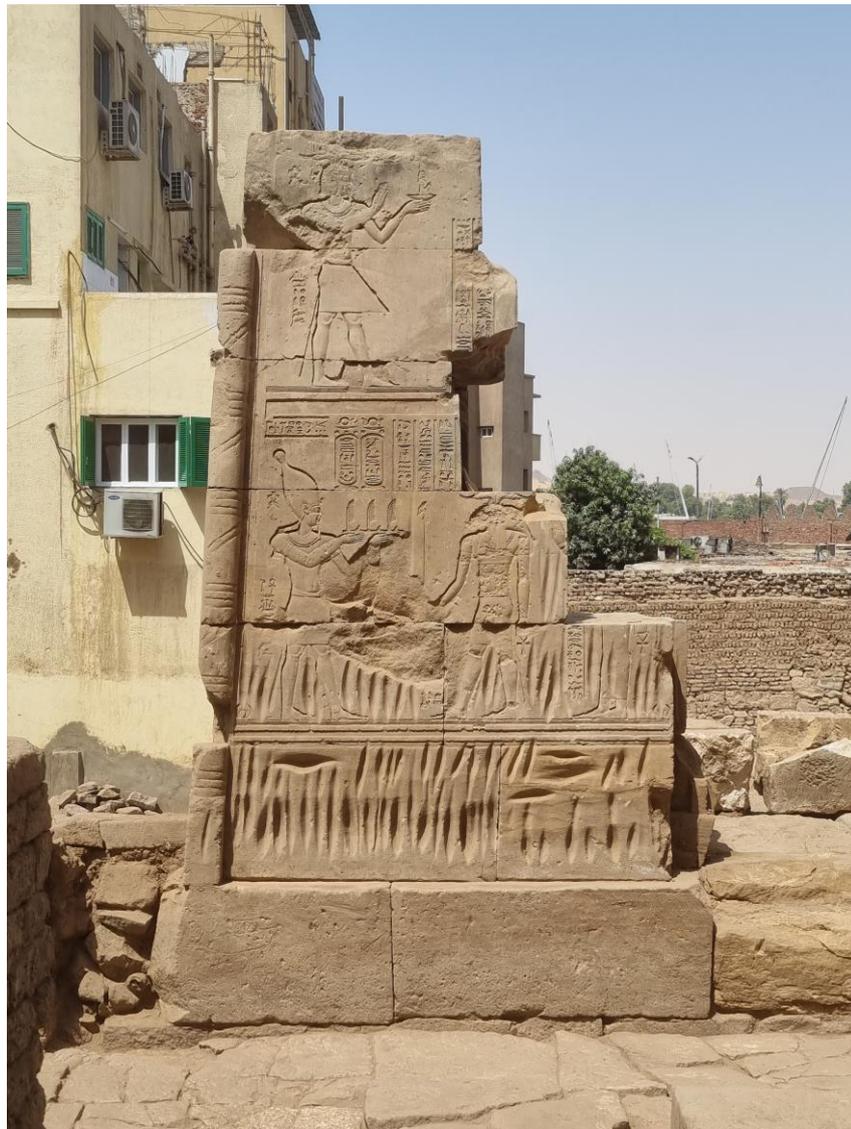
Fig. 13: Detail of the southern part of the facade of the Pronaos from the east.

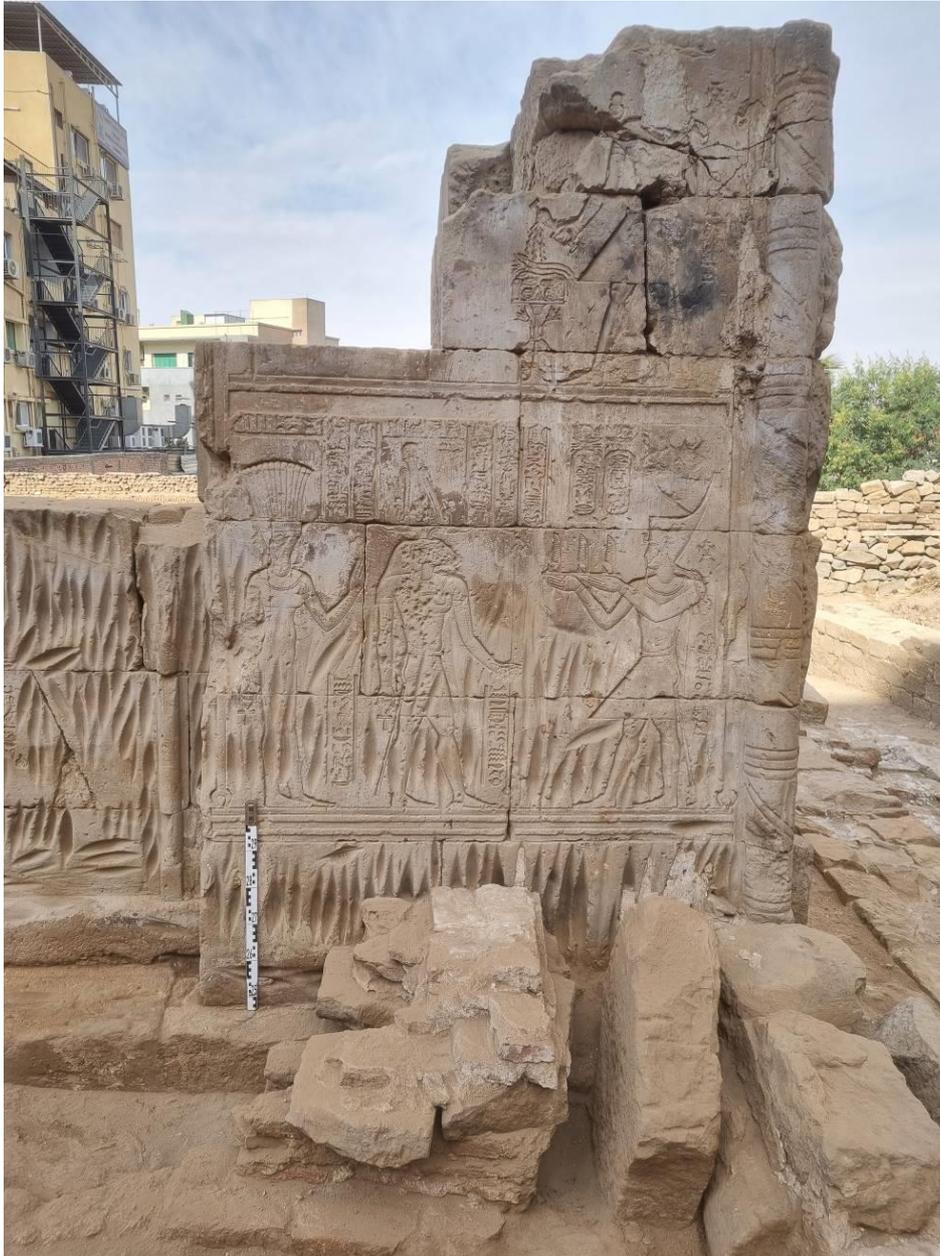
Fig. 15: Detail of the eastern face of the northern part of the Pronaos.

This scene has its equivalent at the northern end of the façade (Figs. 15 and 16). There, in the uppermost preserved register, the emperor stands looking towards the north and libates

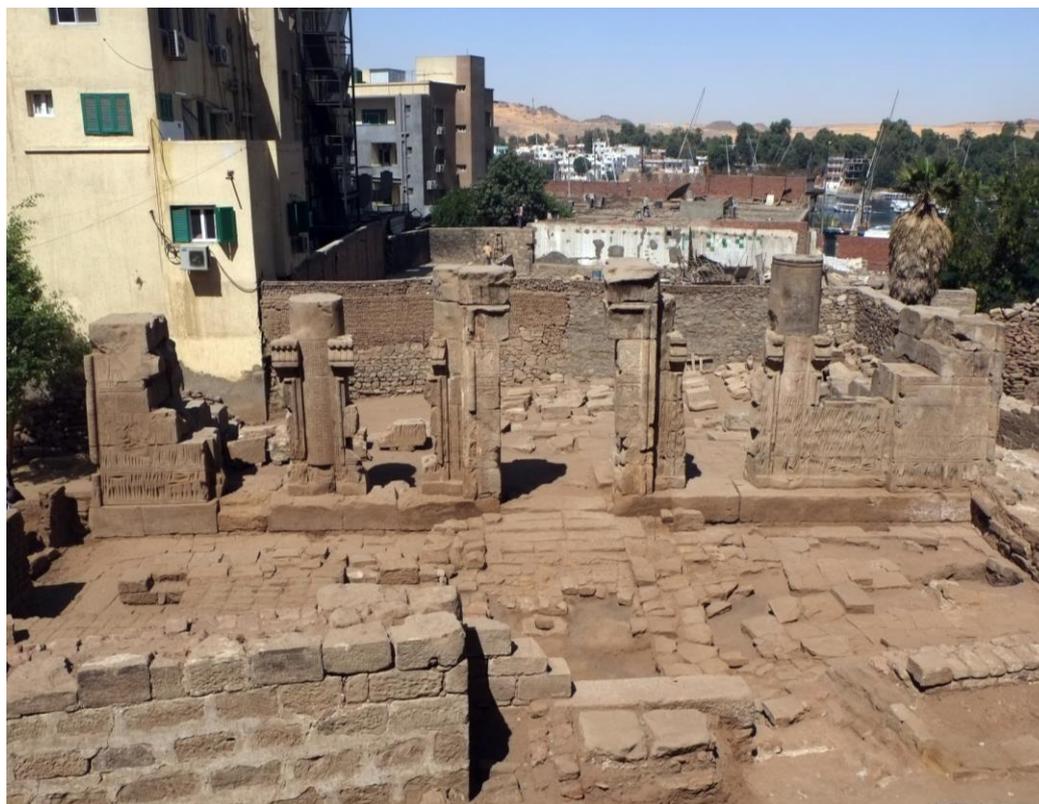
Fig. 16: View of the facade of the Pronaos from the east.

The intercolumnar walls between the corner and the portal of the temple were severely damaged (Fig. 16). The first and biggest breach damaged not only the intercolumnar wall but also the area to the south of it. Only at the northern end of the screen wall, at the central column, can Satet be identified. She is standing and looks towards the south. The relief is framed by an elaborate torus and crowned by a cornice with an uraeus frieze on top of it. Between the northern torus and the column, the sunk relief of a standard crowned by a lotus flower with a cobra on top of it is preserved. The cobra wears the Red Crown symbolizing Lower Egypt (Figs. 17 and 12).

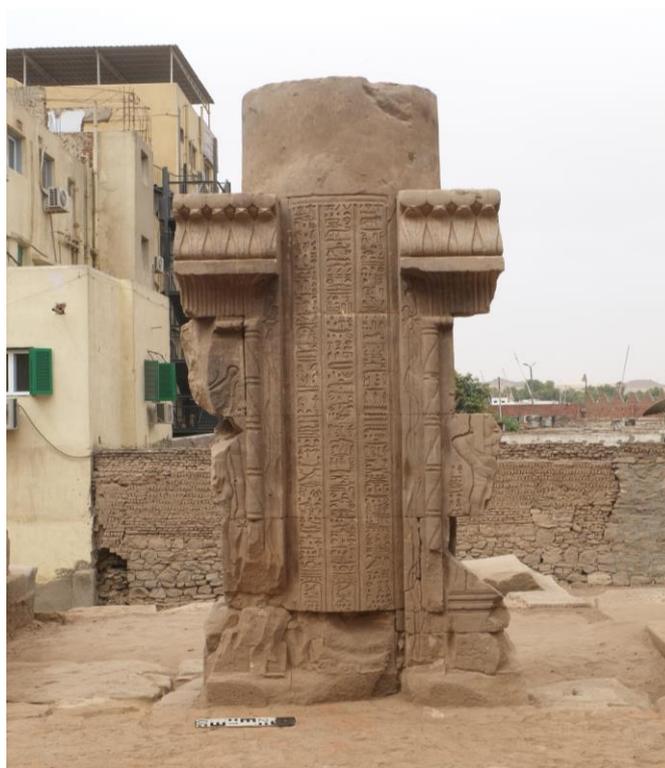
Fig. 17: Column at the southern part of the facade of the Pronaos from the east.

The second intercolumnar wall of the southern half of the façade was in better condition. The breach is ca. 1.20m wide and thus shows the dimensions of a door (Figs. 12, 17 and 18). The frame is only destroyed at the top. It is constructed in the same way as the southern intercolumnar wall. The tori of the frame are again flanked by standards with crowned cobras on

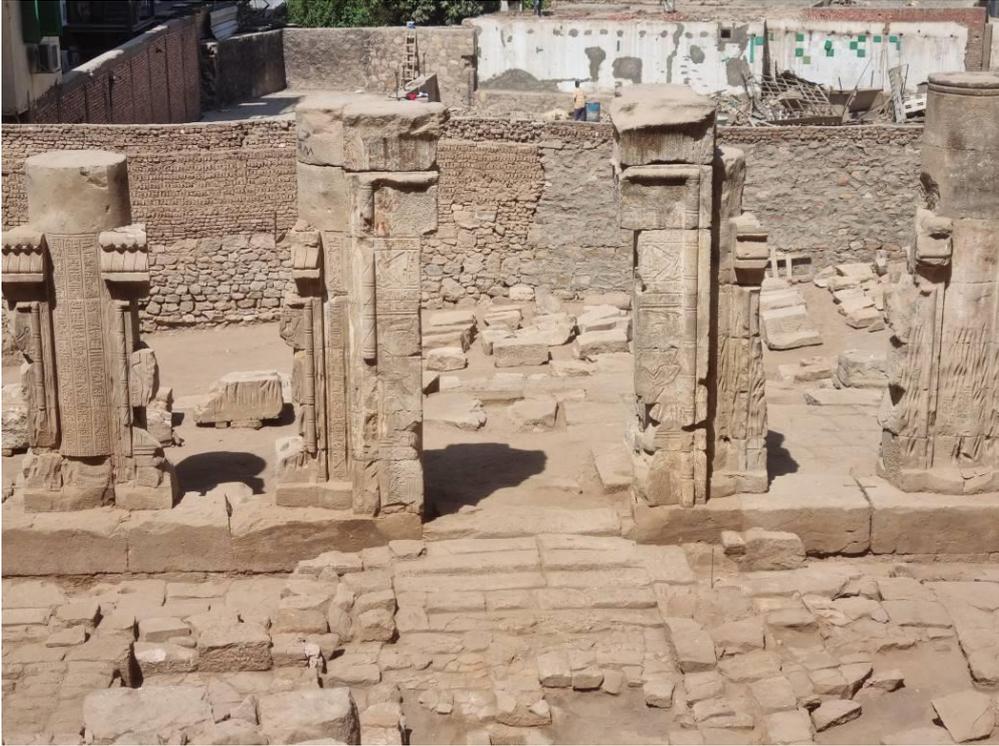
Fig. 18: Detail of the façade of the Temple of Domitian with the portal.

The portal was partly covered by later walls and only became visible completely after this season's work (Figs. 12, 18, 19, 20). All elements of the portal, which had an open lintel, were decorated. Apart from the open lintel, the portal resembles the design of the intercolumnar walls. Both doorjambs show tori that are identical to those observed on the southern part of the façade.⁴⁸ Outside the frame, at the northern and southern limit of the portal, standards that were larger in size but otherwise identical to the ones flanking the intercolumnar walls show the symbols of Upper and Lower Egypt respectively. The standard itself is green and adorned with twining in yellow.

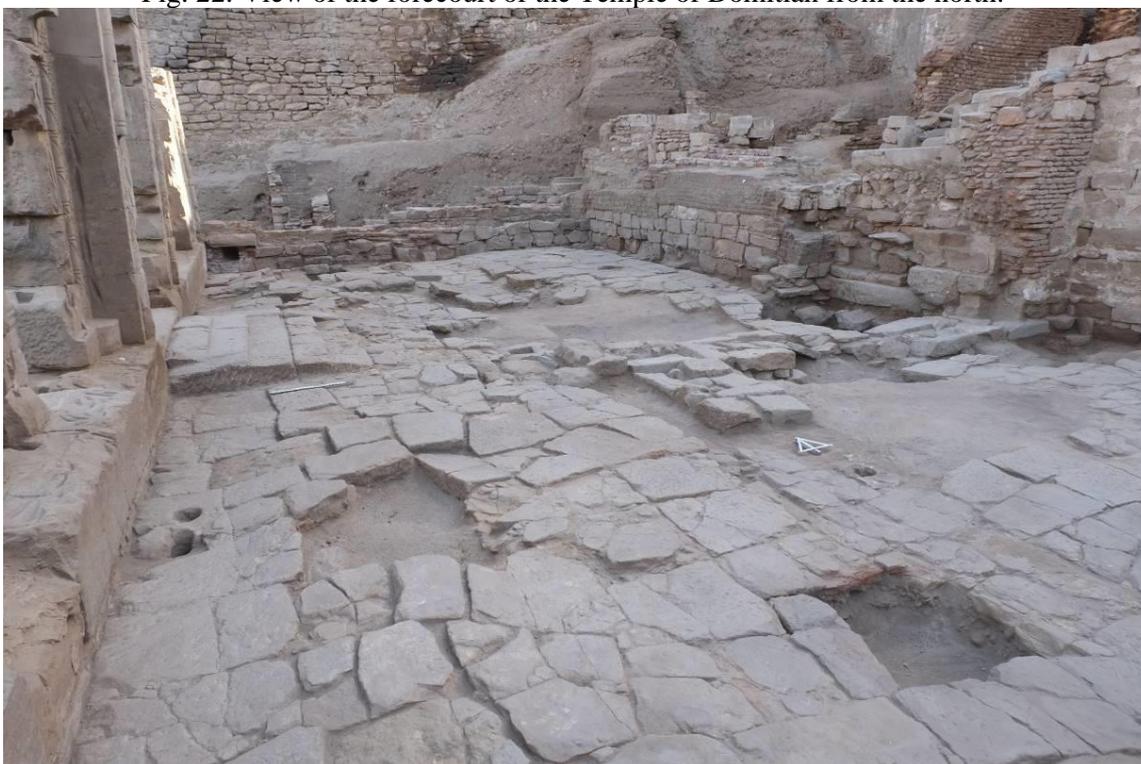
Fig. 23: View of the forecourt from the south-west with damaged pavement.

The pavement consists of sandstone slabs that were carefully set. The pavement was severely damaged by numerous illicit excavations (Fig. 23). Pits, shafts, and tunnels, some of them as recent as 2011, others dating back to the medieval period, were dug in search of treasure due to the temple's visibility throughout its history.

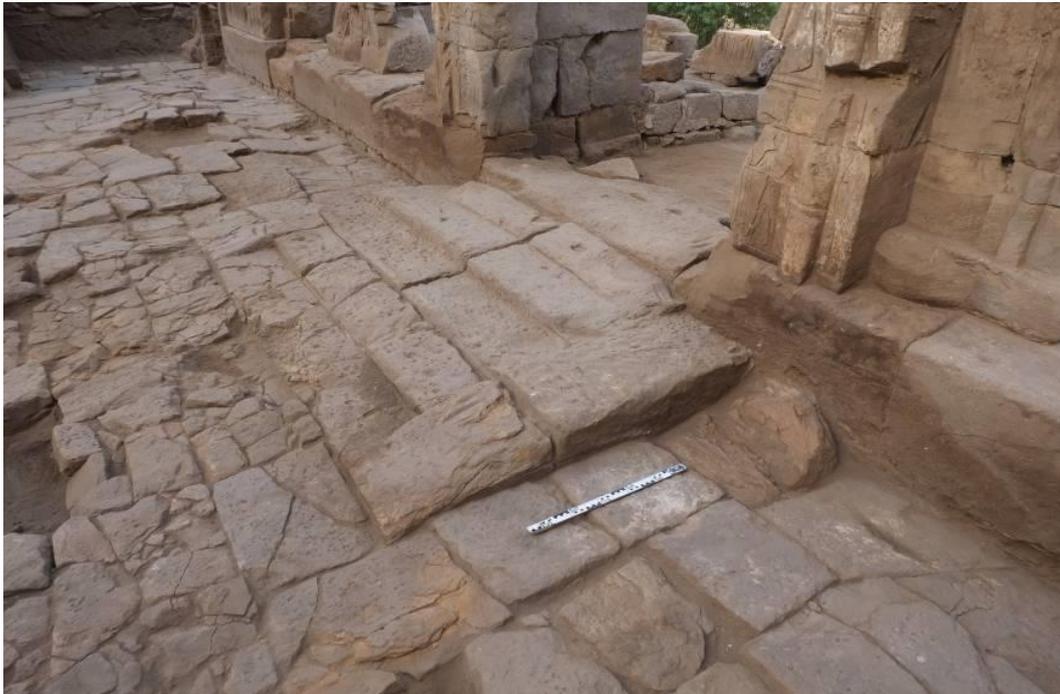
Fig. 24: View of the entrance into the temple with a detail of the staircase from the north.

Due to the difference in elevation (the top of the threshold lies at 98.5m asl, while the average elevation of the pavement is ca. 98.1m asl), a small staircase leads up from the pavement to the threshold of the temple (Figs. 24 and 25). No door-hinges are preserved at the threshold, but both upper door sockets, made of bronze, are still embedded in the two parts of the lintel. Two rectangular holes just behind the elevated part of the threshold show how both wings of the door were locked. At 1.70m, the stairs are exactly as wide as the portal. The ramps (each of them ca. 35cm wide) about the *Stylobat*. The staircase was constructed of three sandstone blocks. Four shallow steps flanked by two narrow ramps were carved into these blocks. The southern ramp was partly chiselled away when a wall was constructed there in the medieval period. Similarly, the northern ramp was damaged when it was partly covered by the foundation of a wall of the earliest phase of House 32 (House 32c). The steps of the staircase were heavily worn as they were in use from the construction of the temple well into the medieval period.

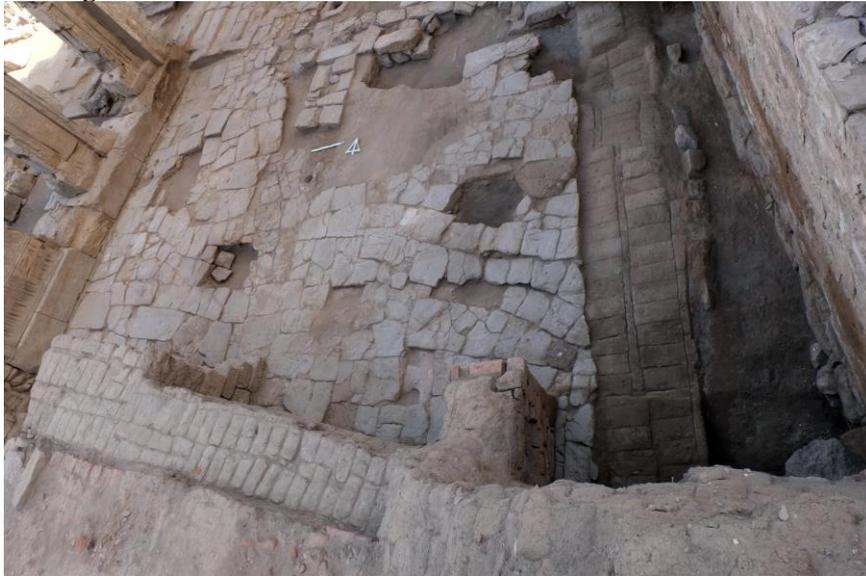
Fig. 27: View of the forecourt from the south-east with the eastern limiting wall of the pavement.

had to be adapted to the predecessor of Street 7 (Figs. 7 and 27). The temple was thus integrated into the existing street grid. Stone slabs leaned against the eastern face of the southern limiting wall of the forecourt. The layers abutting these stones and the exposed parts of the wall itself are typical street layers with small fragments of pottery.⁵⁴ The northern limit of the forecourt is still covered by medieval walls and will be investigated next season.

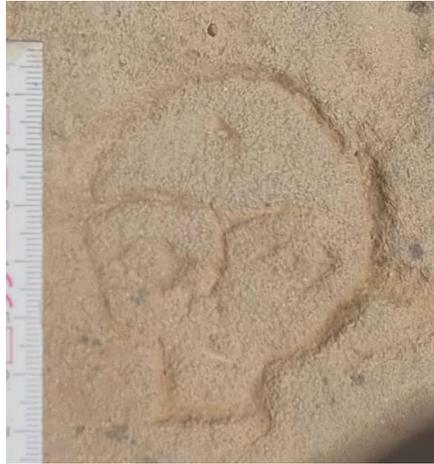
Fig. 28: Graffito on the pavement of the temple forecourt.

details, only one figural graffito, a highly stylized human face, was observed on the surface of the pavement (Fig. 28).

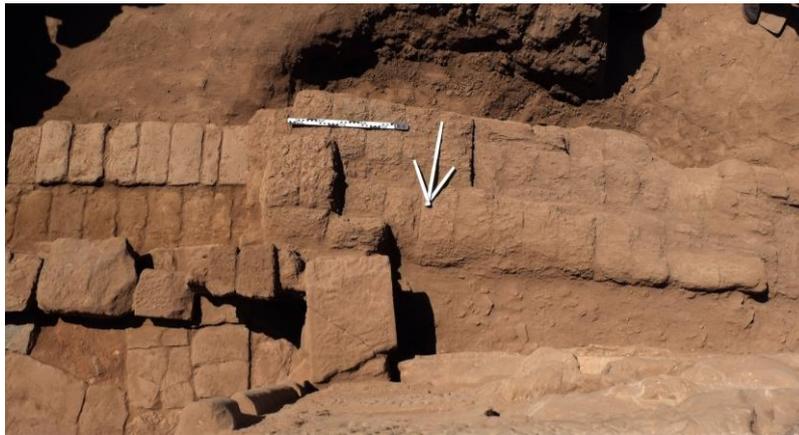
Fig. 30: Gap between the southern wall of House 20 and the southern wall of the temple.

The southern wall of this building was not destroyed and in parts was even repaired when the temple was constructed. It thus covered the rough southern face of the foundation of the temple and served as terracing wall towards the contemporary surface of Street 1 to the south that was ca. two metres lower than the pavement of the forecourt. Due to a slight difference in orientation the gap between this wall and the southern wall of the temple varied in width. While the south-western corner of the Pronaos nearly touched the wall, the south-eastern corner was ca. 50cm further to the south. The resulting gap was filled with sandstone chips, probably from the part-removal of the still visible bosses. As the preserved upper level of the infill of the gap was ca. 0.5m higher than the pavement of the forecourt, the gap was walled up with sandstone rubble at its eastern end (Figs. 13, 30 and 31). Further down the slope, the distance between the southern face of the Naos and the terrace was more than 3.50m. There only the foundations of the temple are preserved, and the layer of stone chips was already removed. Thus, the larger gap between the Naos and the wall was filled with compact mud-brick debris and mud mortar. The southern limiting wall of the forecourt abutted the eastern end of the southern wall of former House 20.

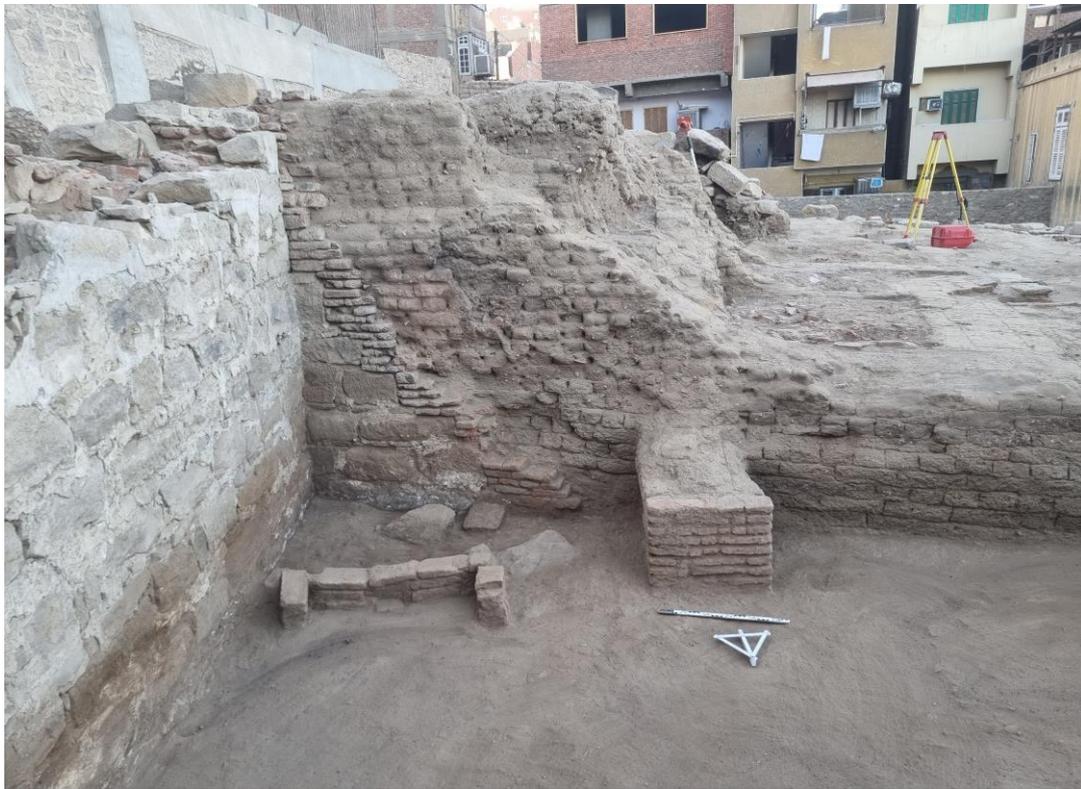
Fig. 40: Northern face of the southern wall of House 32b.

At the same time as the eastern wall, the southern wall of the house and the northern wall of Room 5 were renewed. The southern wall was constructed against the northern face of the southern wall of House 32c. The wall was made of mud bricks resting on a foundation of sandstone blocks that were put directly onto the pavement of the forecourt of the Temple of Domitian. The northern wall of House 32c/Room 5 was partly removed and replaced with a new wall of the same dimensions and construction as its predecessor. Both walls were interlocked with the eastern wall of the house by a special method (Fig. 40). In both cases, the stones of the eastern wall continue from the corner westwards in a stepped manner. On top of the stones, several courses of fired bricks continued these steps, and then mud bricks were put on top of them.

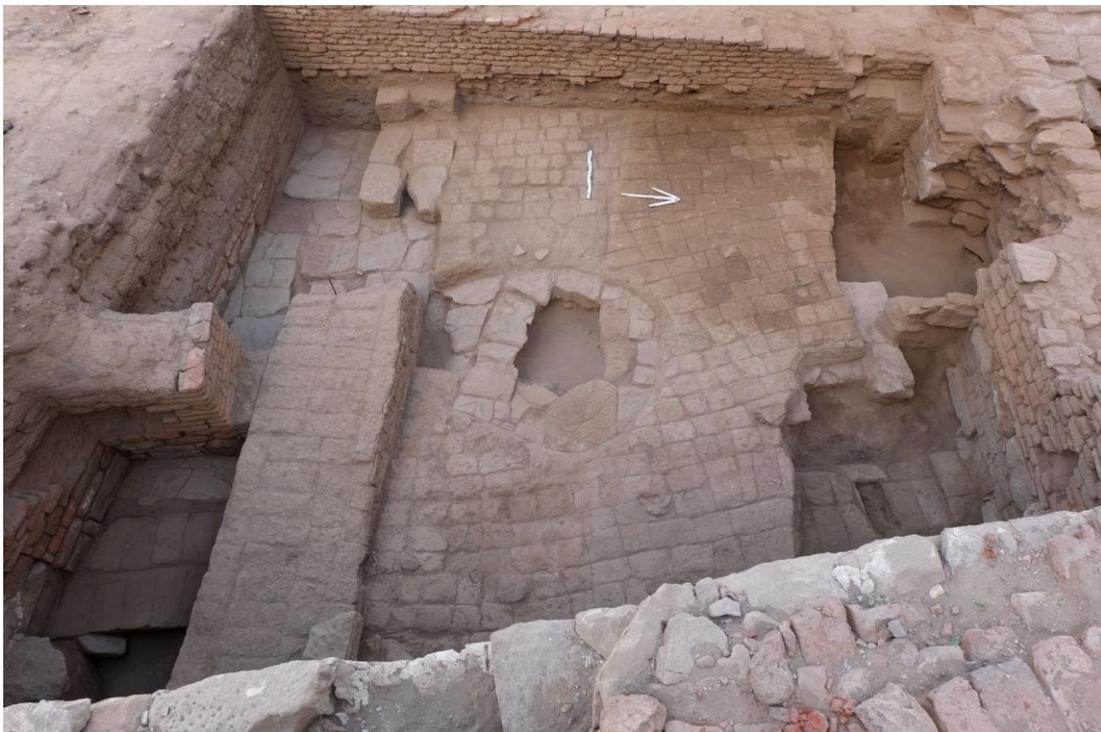
Fig. 41: Mud brick pavement in House 32b/Room 5.

The first floor in House 32b/Room 5 was a pavement of unfired mud bricks (Fig. 41). Only half-bricks were used. Due to the bad quality of these bricks the room showed numerous consecutive floors before House 32b was given up.

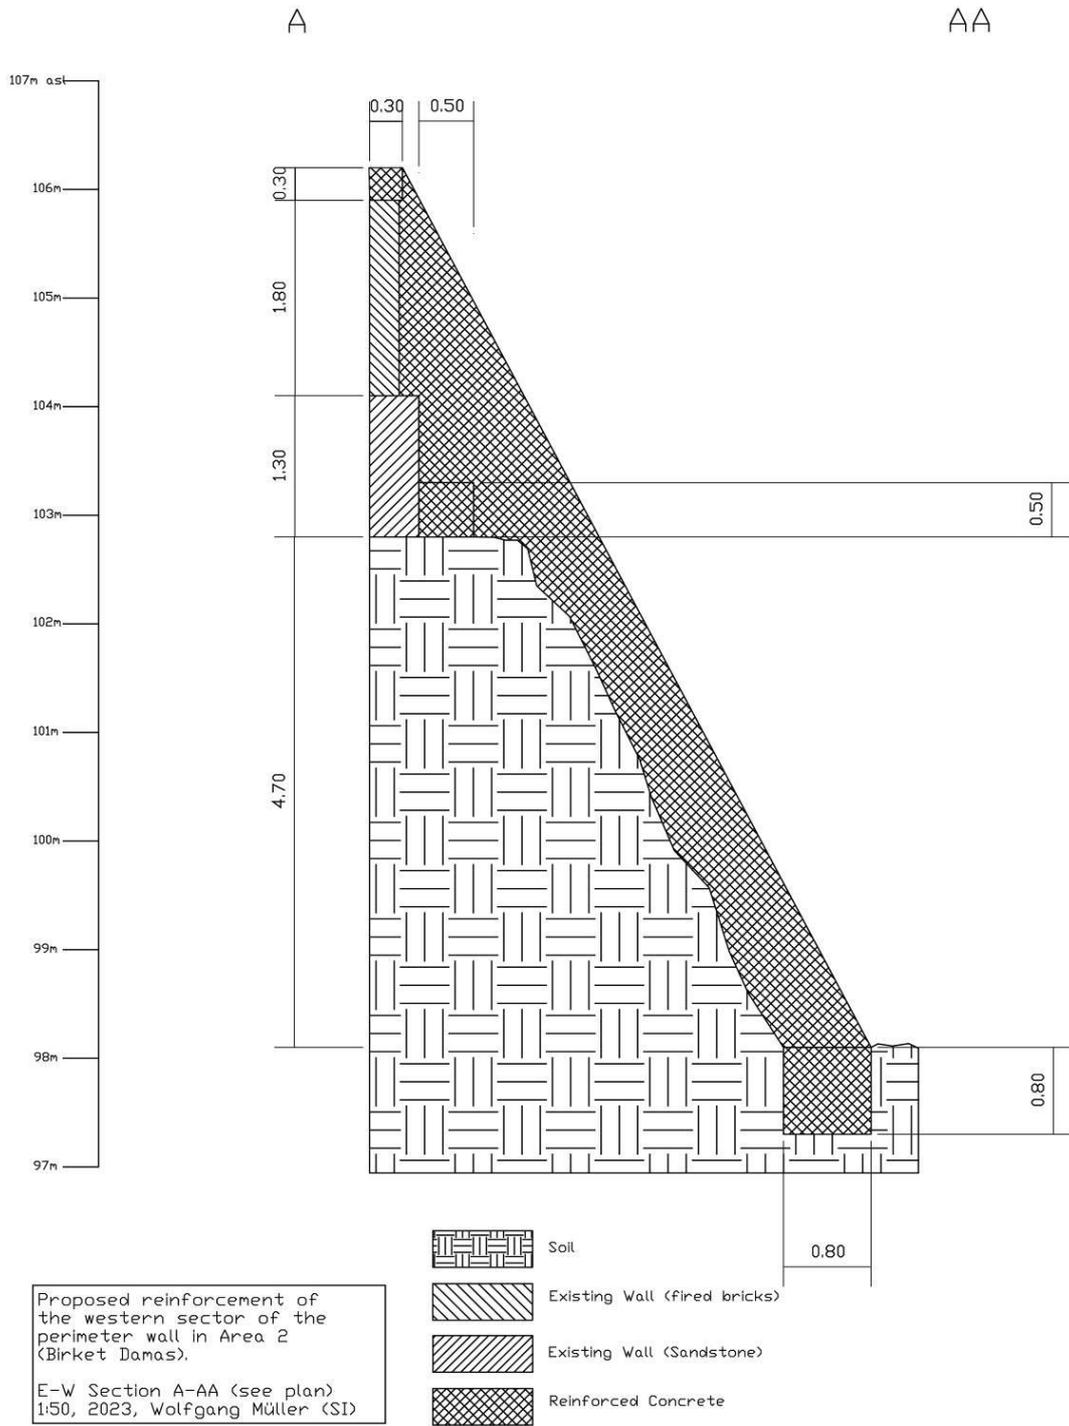
Fig. 46: Area 2: Section through a buttress (for exact location see Fig. 47)

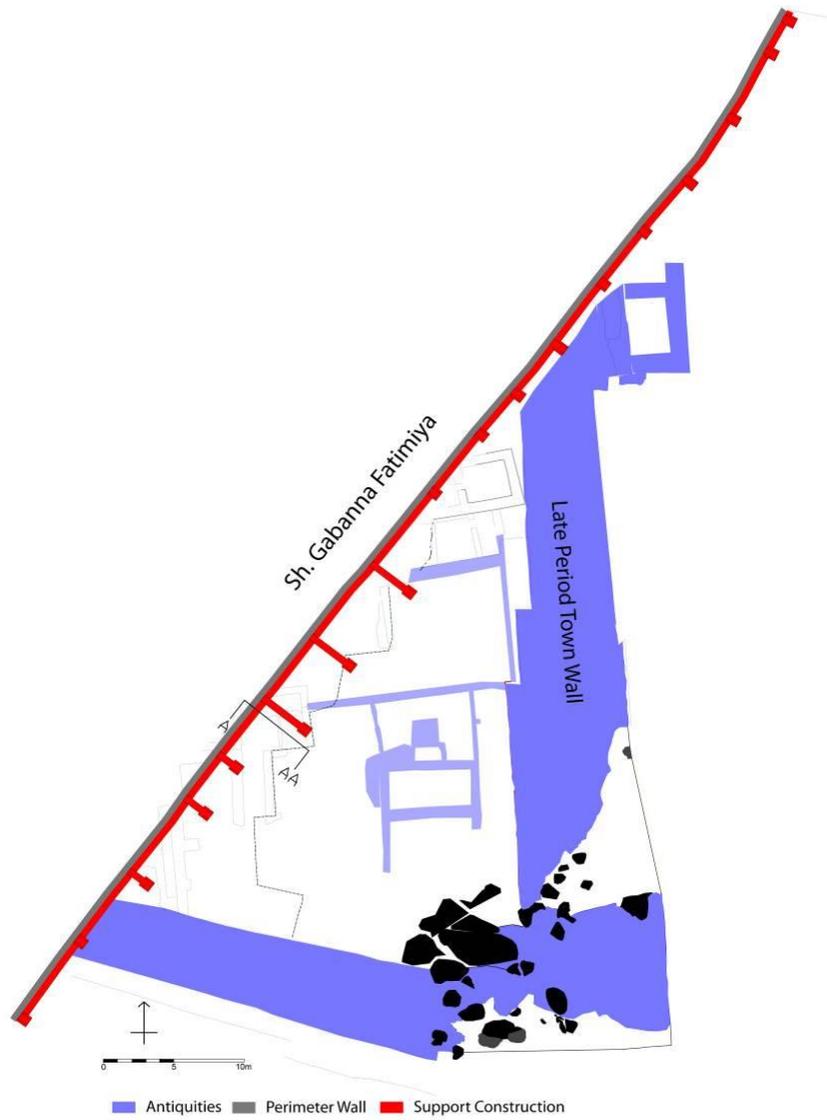
Fig. 47: Area 2: Plan of the reinforcement of the western perimeter wall.

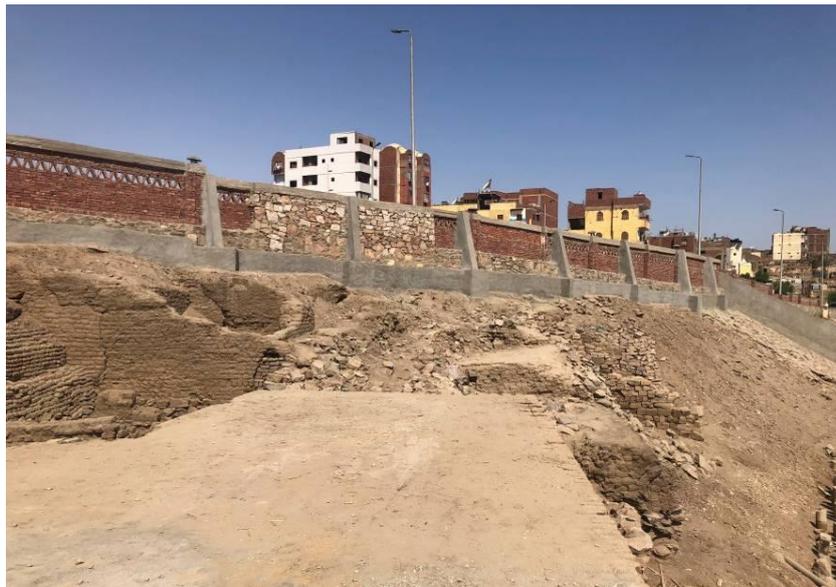
Fig. 48: Area 2: View of the reinforcement of the western perimeter wall (northern part).
