Report on the
24th Season of the Joint Swiss-Egyptian Mission
in Syene / Old Aswan (2024)

1. Introduction: The current status of site management

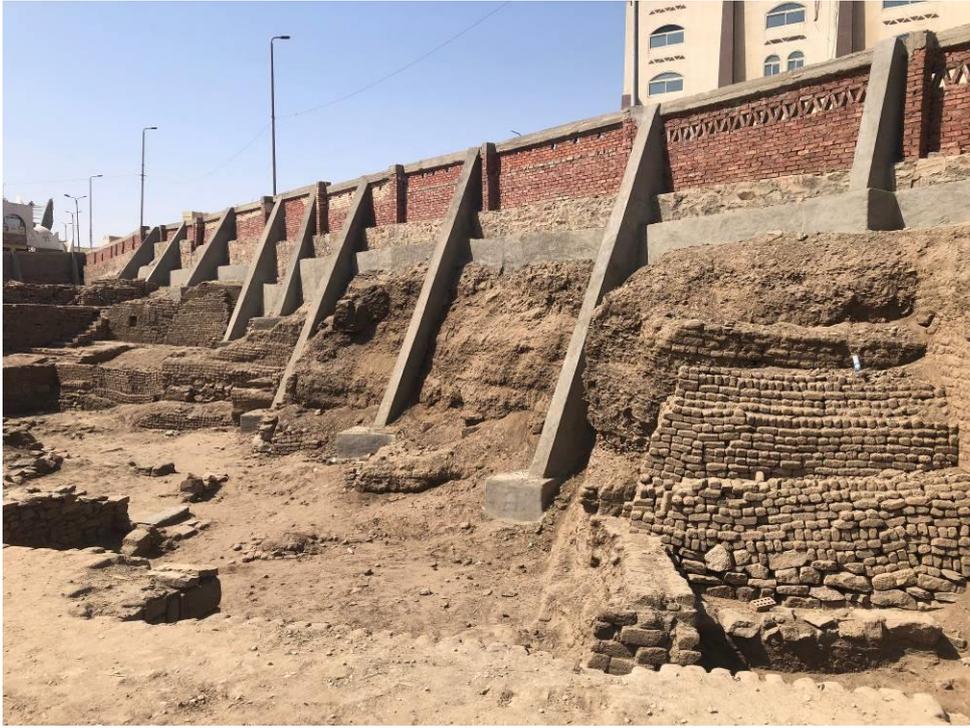
Fig. 49: Area:2: View of the reinforcement of the western perimeter wall (southern part).
